Bushfire Attack Level Assessment

95 Idonia Street, Bridgeman Downs

Prepared for Fairland Group Pty Ltd

Client Manager: Kelly Matthews Report Number: PR18104_BAL_95 Idonia St, Bridgeman Downs

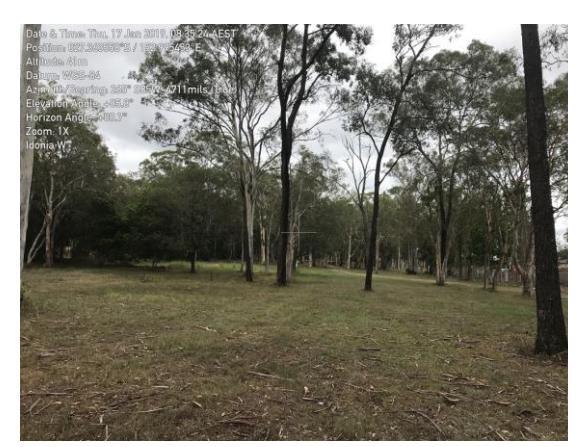
A site assessment was undertaken on 17^{th} January 2019 to inspect and classify vegetation surrounding the site. This assessment determined that vegetation to the immediate south and west of the site on Lots 11RP93688 (107 Idonia Street), 6RP93687 (357 Beckett Road) and 5SP227448 (365 Beckett Road) consists of Eucalypt open woodland which has been significantly modified through the removal of all understorey strata. Tree height in this community ranges from 18 to 26 metres, with an estimated canopy foliage cover of 10 - 20%. Canopy species within this patch of vegetation consist of broad-leaved paperbark (*Melaleuca quinquenervia*), Queensland blue gum (*Eucalyptus tereticornis*), grey ironbark (*E. siderophloia*), pink bloodwood (*Corymbia intermedia*). The ground layer appears to be regularly maintained in a low hazard state (< 100 mm height) through mowing or slashing (**Plates 1 – 2**).

Plate 1: View of adjoining vegetation at 107 Idonia St looking west.

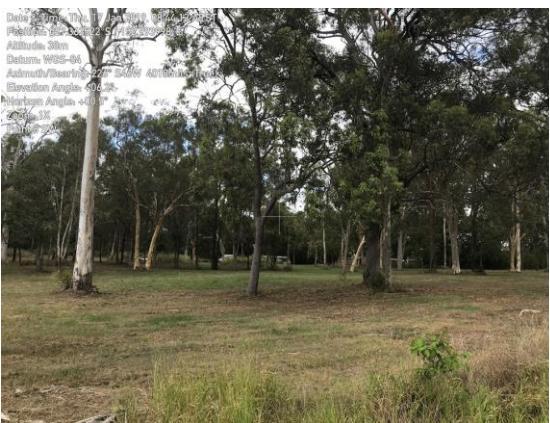
Plate 2: View of adjoining vegetation at 365 Beckett Road looking south-west.

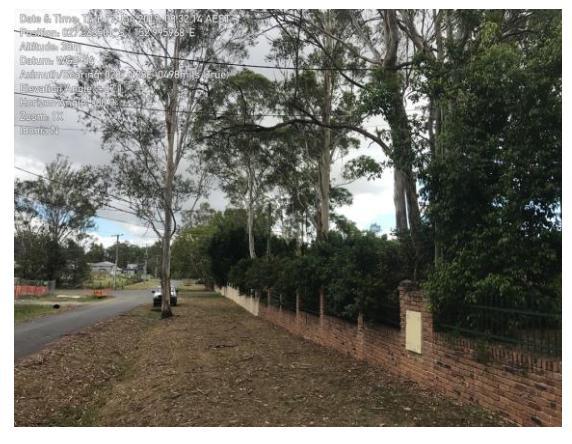
Vegetation to the east of the site on Lots 19RP93688 – 22RP93688 (88 to 112 Idonia Street) consists of landscape vegetation with an overstorey of mature native canopy trees, predominantly Queensland blue gum (*E. tereticornis*) (**Plate 3**).

Plate 3: View of vegetation to the east of the site facing north overlooking Idonia Street.

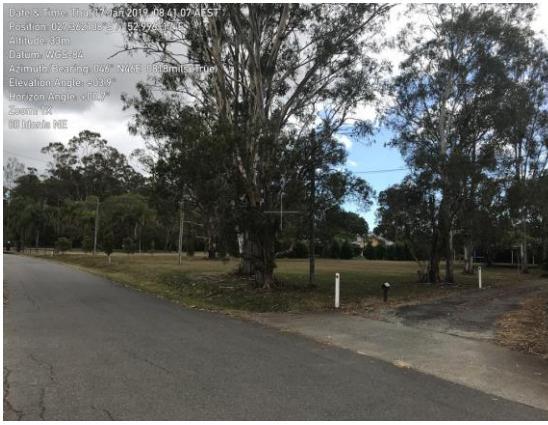
Vegetation to the north of the site within the western portion of Lot 13 RP93688 consists of a small patch of Eucalypt open forest with a predominantly unmanaged understorey (**Plate 4**). The eastern portion of this lot supports unmanaged grassland (**Plate 5**).

Plate 4: Vegetation at 80 Idonia Street looking north-east.

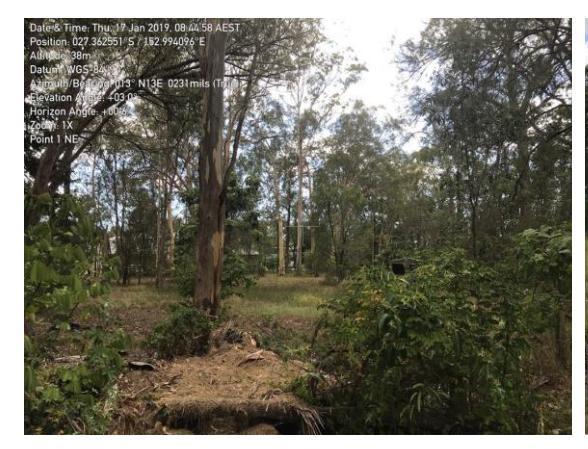
Plate 5: View from southern boundary of the 48 Endell Street looking north-east.

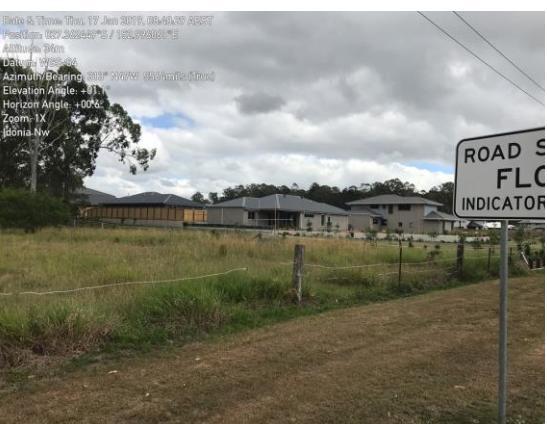
Plate 6: Unmanaged grassland within eastern portion of 48 Endell Street.

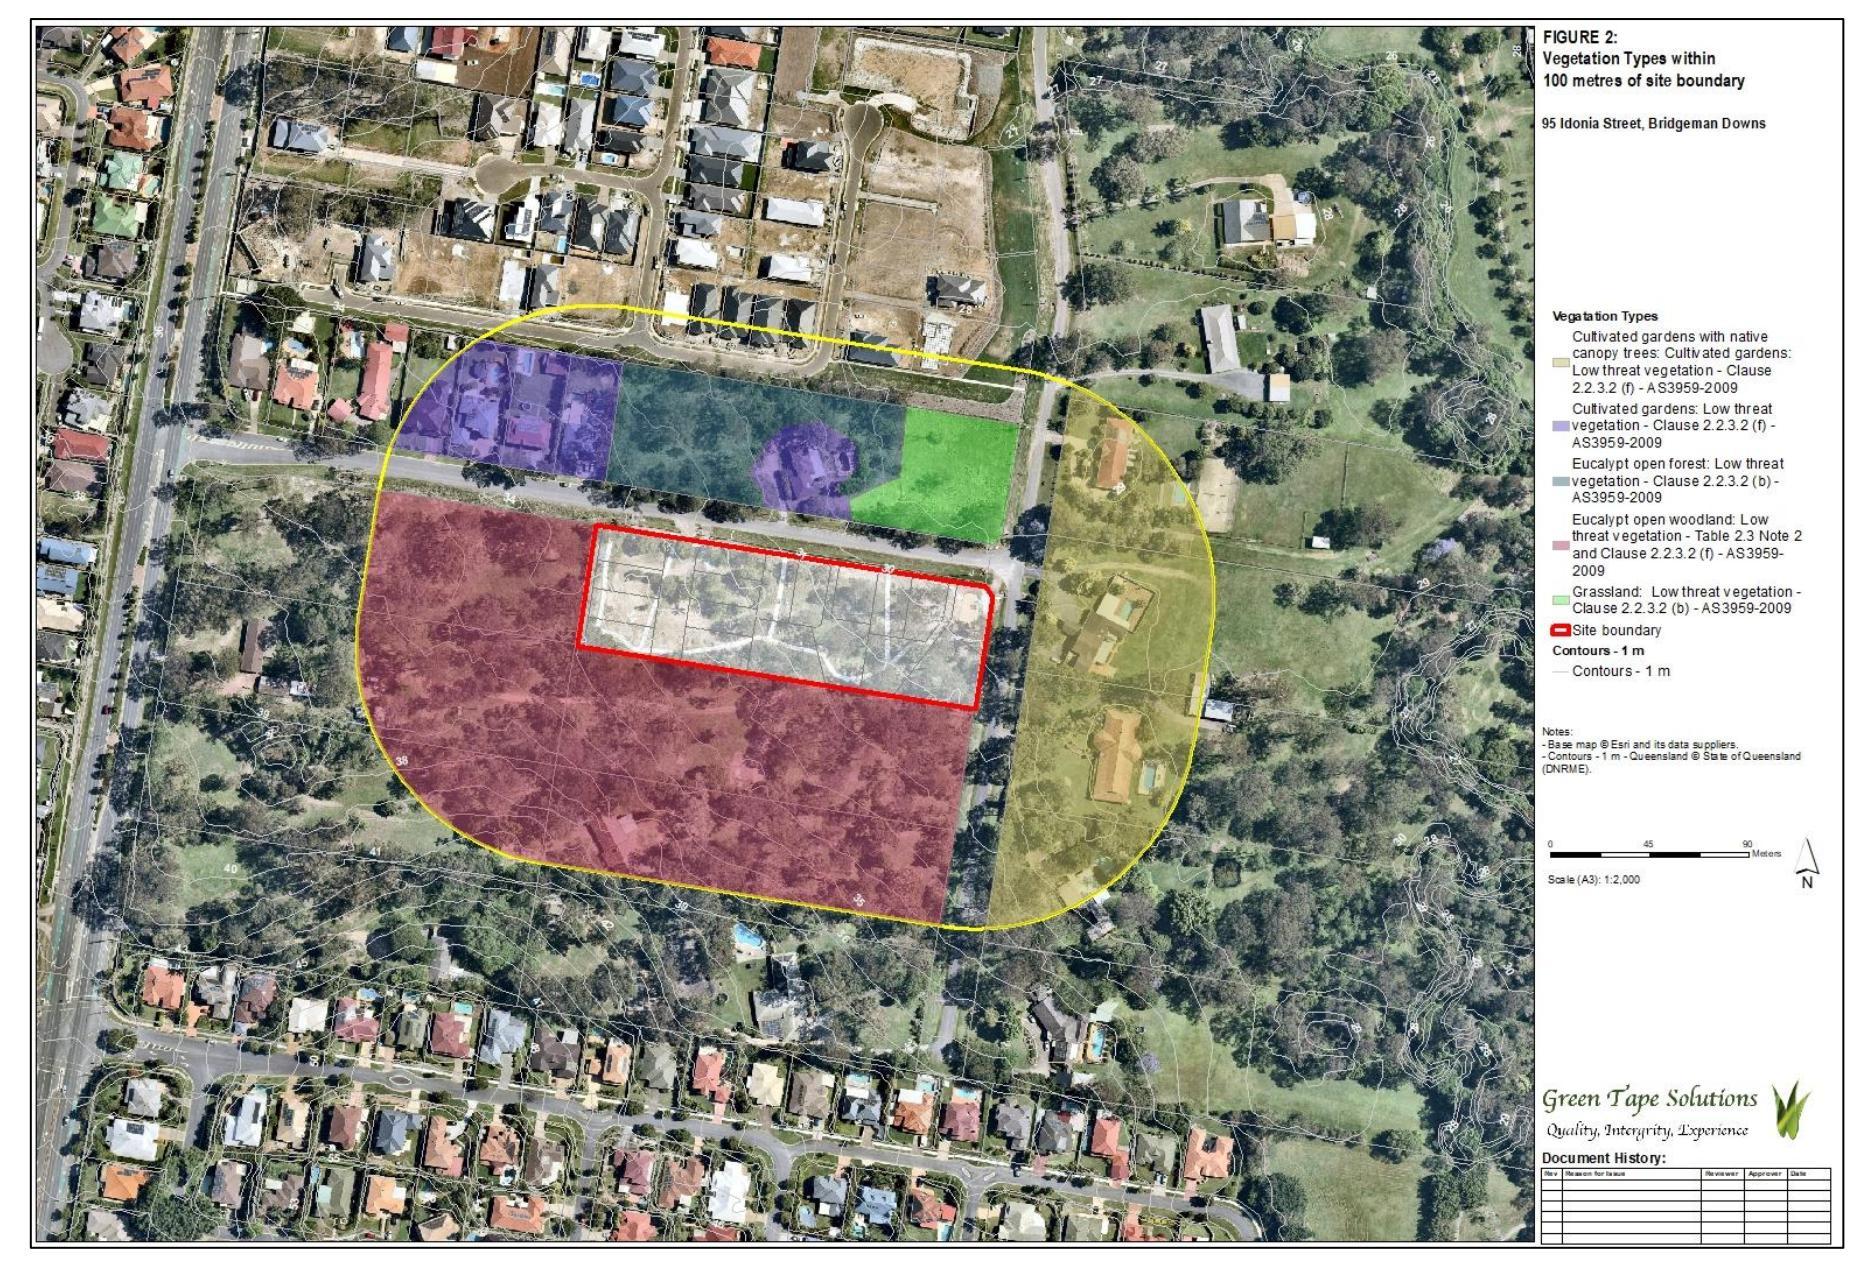
The location, extent and type of each vegetation community within 100 metres of the site is provided in **Figure 2**.

On the basis of exclusions for low threat vegetation outlined in Section 2.2.3.2 of AS3959-2009, all of the vegetation within 100 m of the site is excluded from classification. In accordance with Note 2 of Table 2.3, Eucalypt open woodland to the immediate south and west of the site has been rated by its understorey, which in this case is managed grassland that is maintained in minimal fuel condition. Where vegetation is assessed as low threat, the bushfire attack level is classified as BAL-LOW and no further assessment is required. **Table 1** provides a summary of the classification of this vegetation.
